# **Dam Safety Assessment of CCW Impoundments**

**Chesapeake Energy Center**

**United States Environmental Protection Agency  
Washington, DC**

June 17, 2010

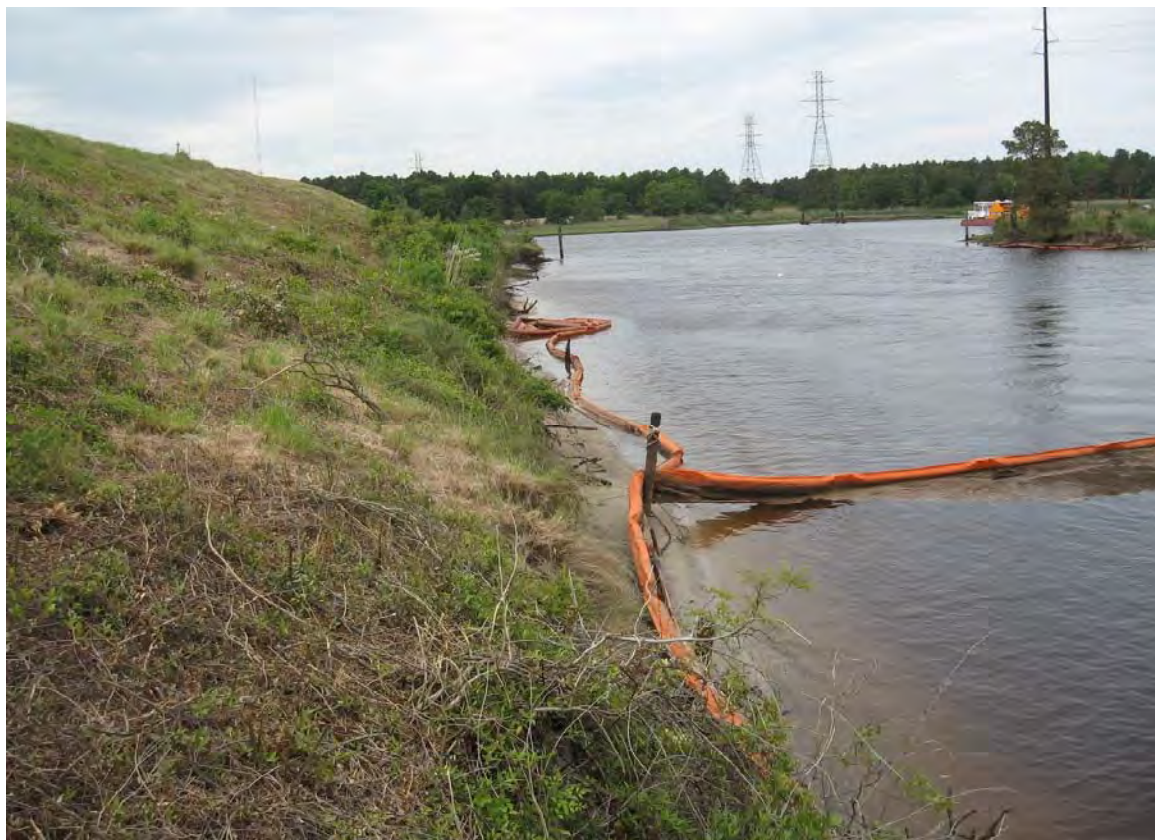
Photo Number:  
1

Description:  
Outboard slope  
and toe of  
Western  
embankment

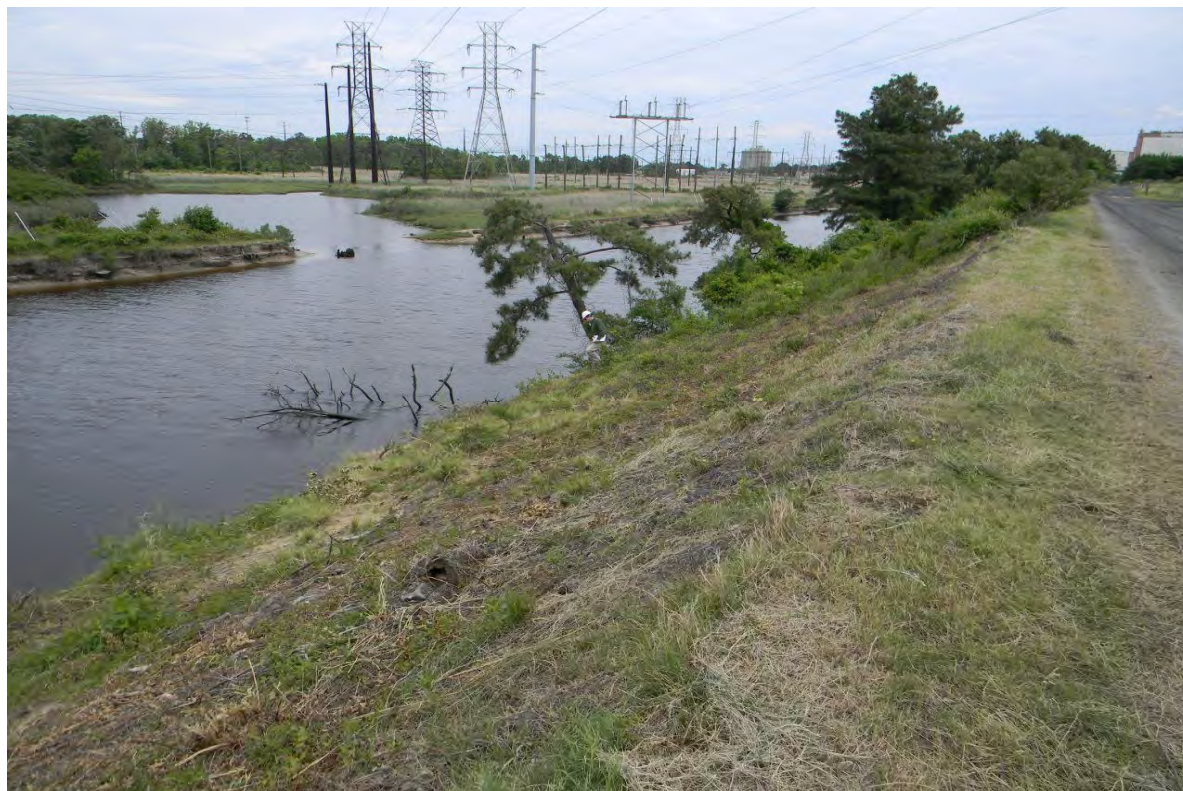
Photo Number:  
2

Description:  
Outboard slope  
and crest of  
Western  
embankment

Note vegetation  
remaining north  
of  
impoundment

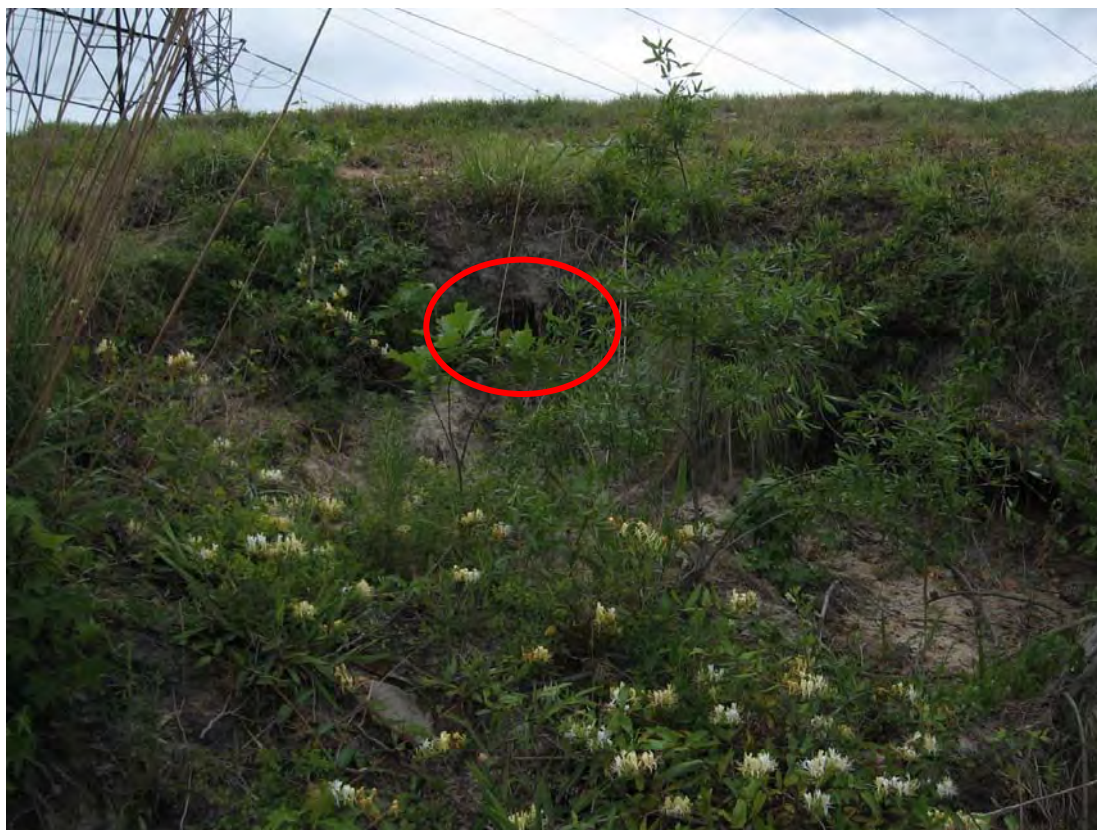
Photo Number:  
3

- The western embankment has experienced localized erosion and/or shallow slope failures in the native soils that form the embankments foundation. Some animal burrows were also observed on the western embankment (Photo 3).

Description:  
Erosion and/or  
localized  
shallow slope  
failure of  
western  
embankment.

Note animal  
burrow.

- Continue to observe and monitor the condition of the eastern and western embankment slopes as recommended by Schnabel until short and long term repairs are made.
- Annual inspections and six year reporting per the VDCR requirements for regulated structures.

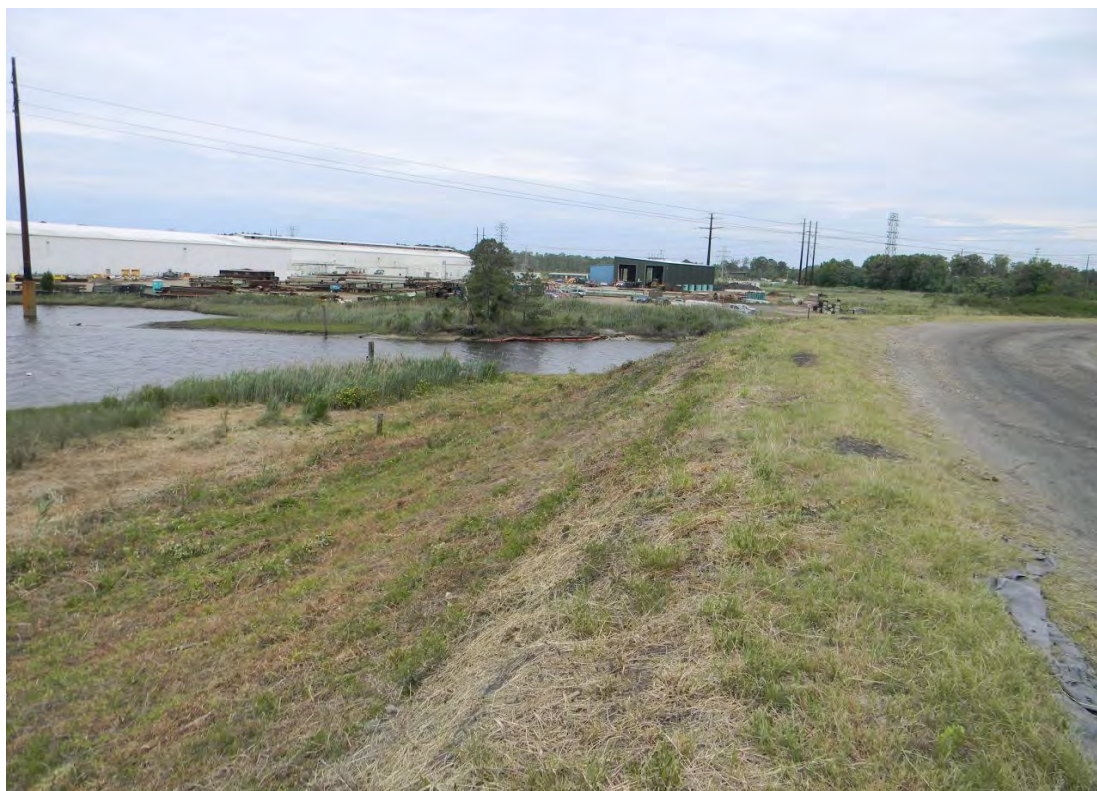
Photo Number:  
4

Description:  
Outboard slope  
and crest of  
southern  
embankment

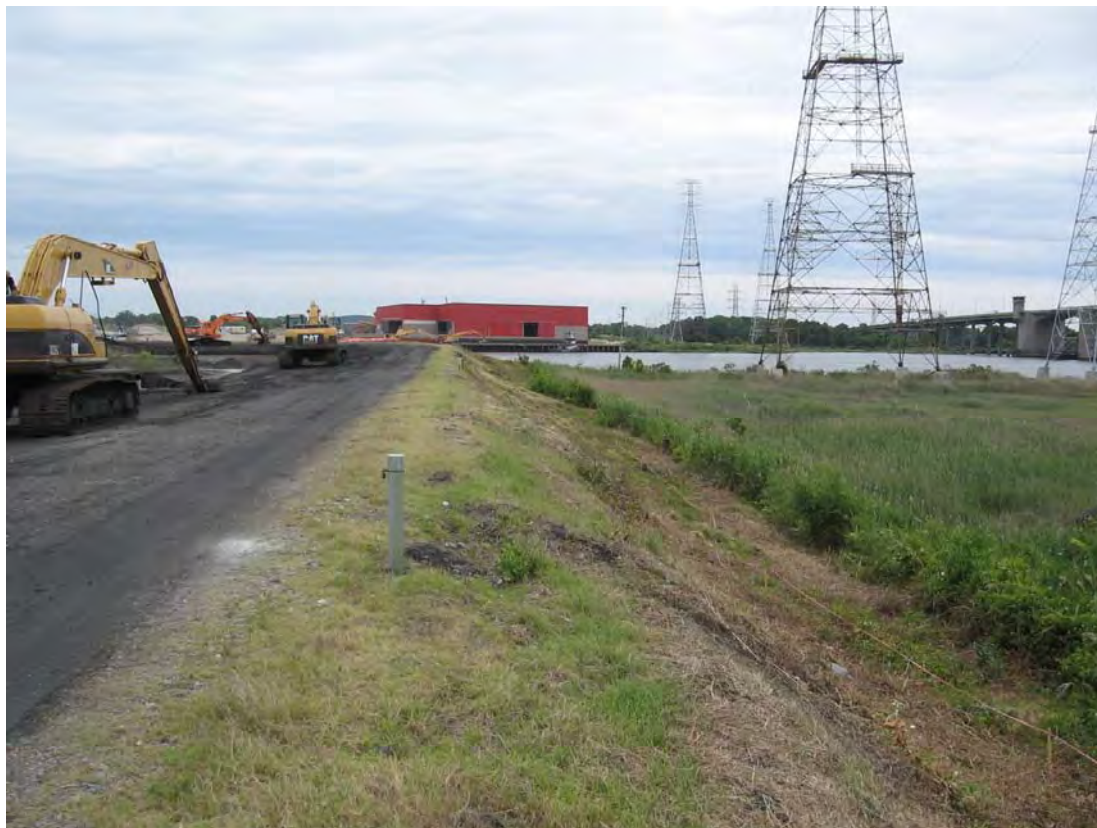
Photo Number:  
5

Description:  
Outboard slope  
and crest of  
southern  
embankment

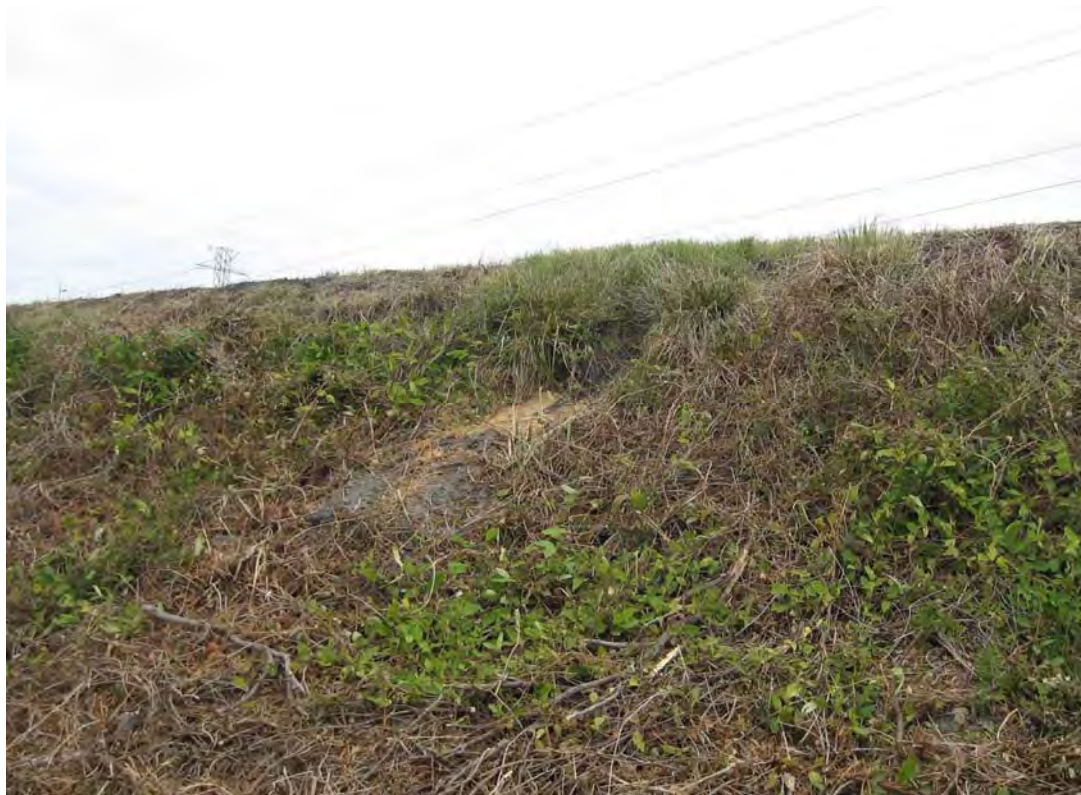
Photo Number:  
6

Description:  
Minor erosion  
on outboard  
slope of  
southern  
embankment

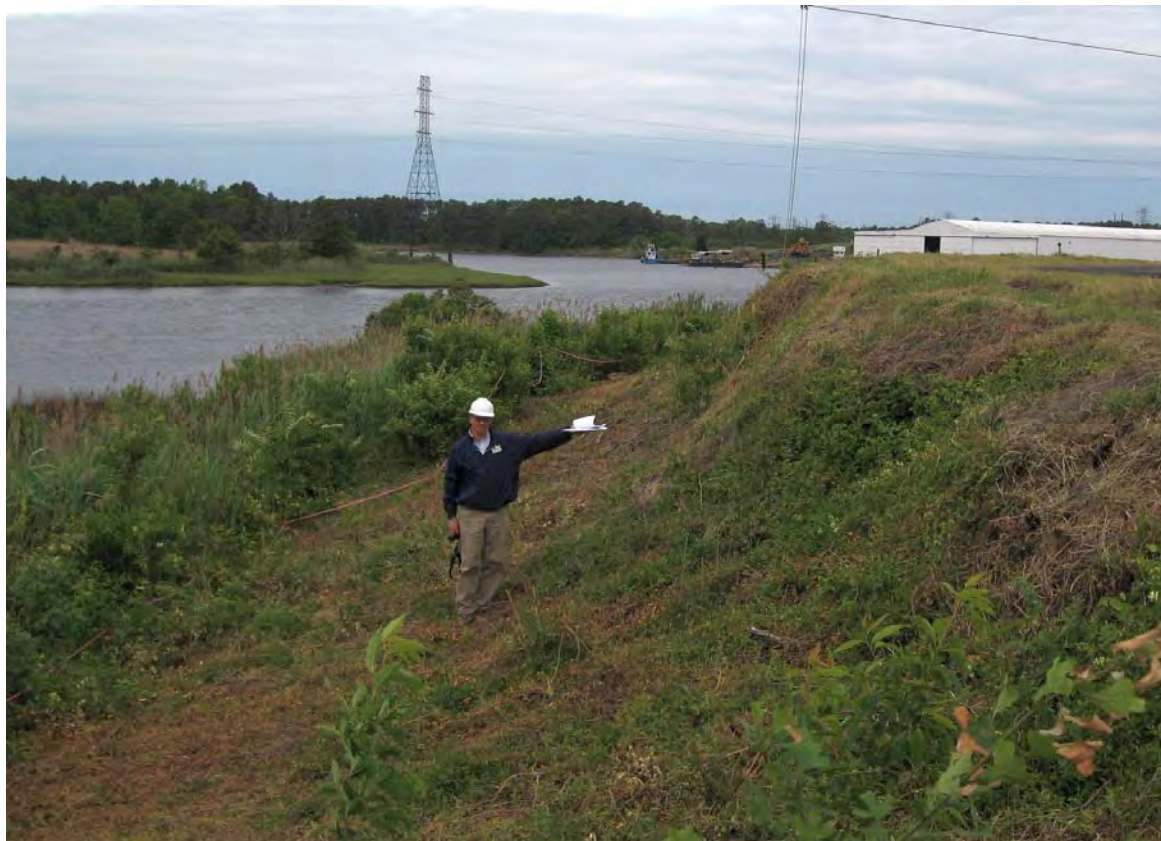
Photo Number:  
7

- The eastern embankment has experienced localized erosion and/or shallow slope failures (Photo 8).
- The outboard slope of the embankment appears to have been constructed steeper than 2H:1V (Photo 7).

Description:  
Outboard slope  
of southern  
embankment

Note slope of  
upper portion  
of embankment

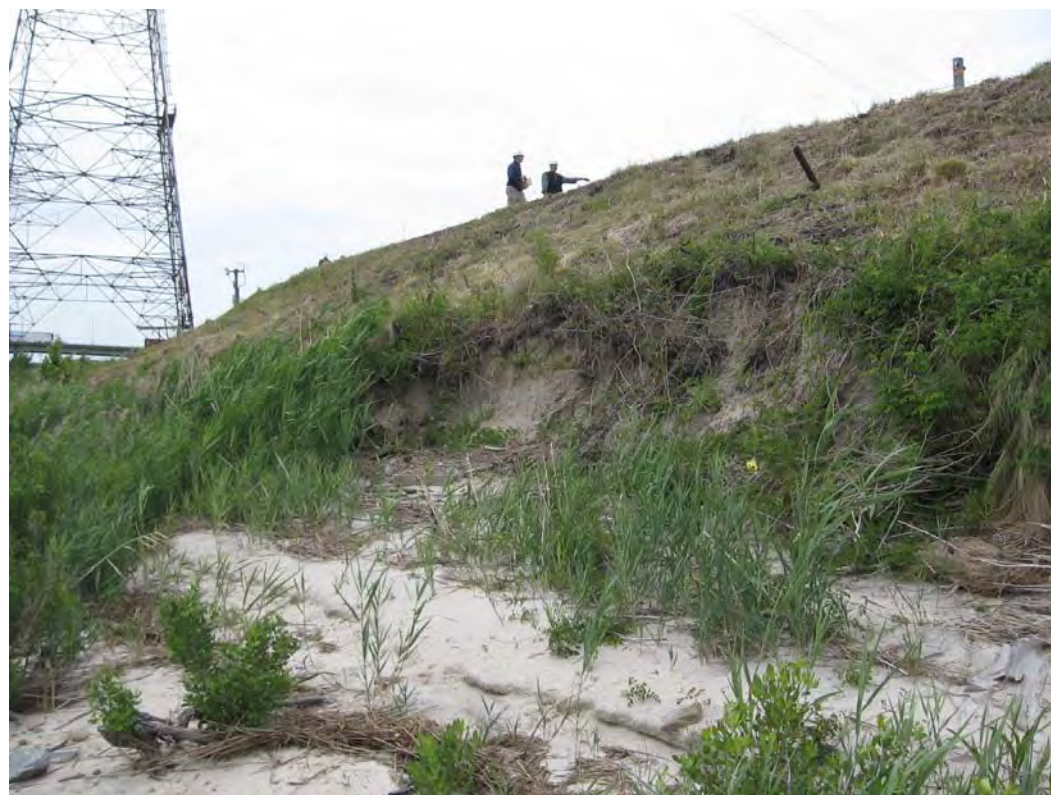
Photo Number:  
8

Description:  
Outboard slope  
and toe of  
eastern  
embankment

Note erosion or  
localized slope  
failure of toe

- Perform topographic surveys of the southern, eastern and western embankments (**as soon as possible**).
- Develop basic plan and details to repair the eastern embankment toe erosion/failure and hire civil contractor to make the recommended repairs (**develop plan concurrent with survey, timing of repairs subject to permitting requirements**).

- Perform conceptual study and develop conceptual plan, details and cost estimate for (a) improving the eastern embankment's long-term stability using sheet pile wall at toe; and (b) placing riprap buttress along discharge canal to restore eroded areas below the western embankment. Bathymetric survey recommended by Schnabel was performed several years ago and may be able to be utilized in the conceptual study (**next three months**).

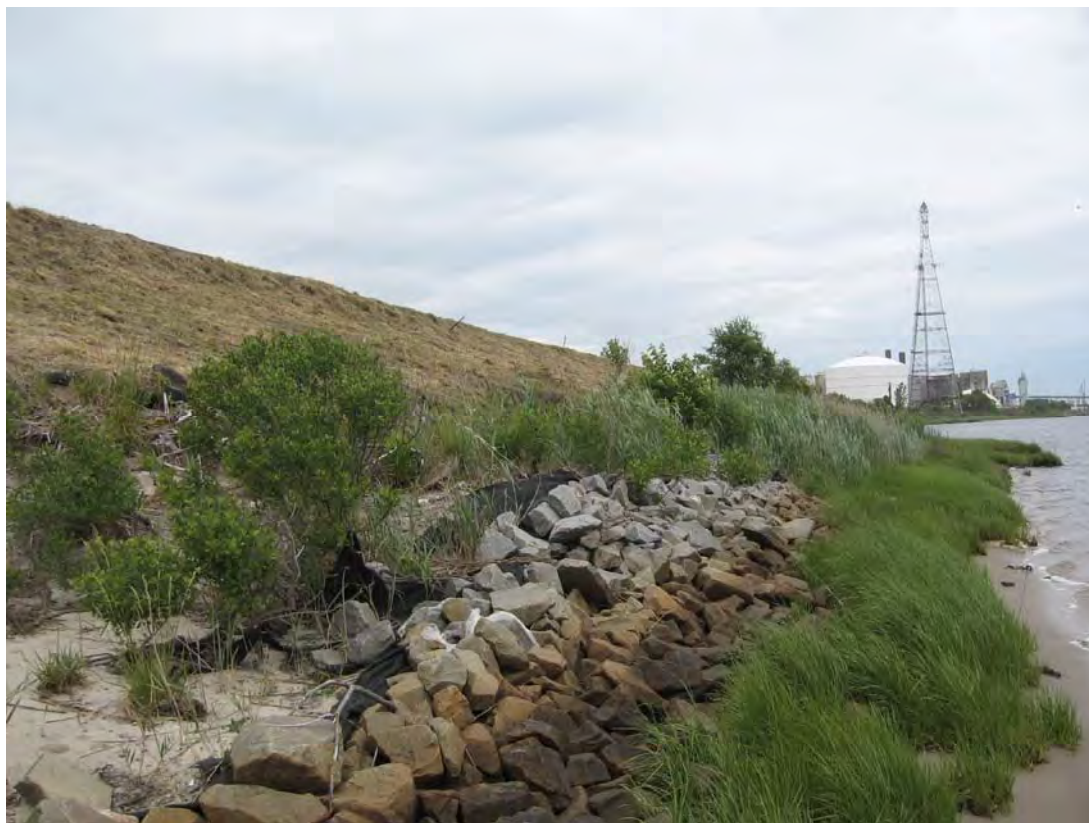
Photo Number:  
9

Description:  
Outboard slope  
and toe of  
eastern  
embankment

Note riprap  
erosion  
protection of  
toe

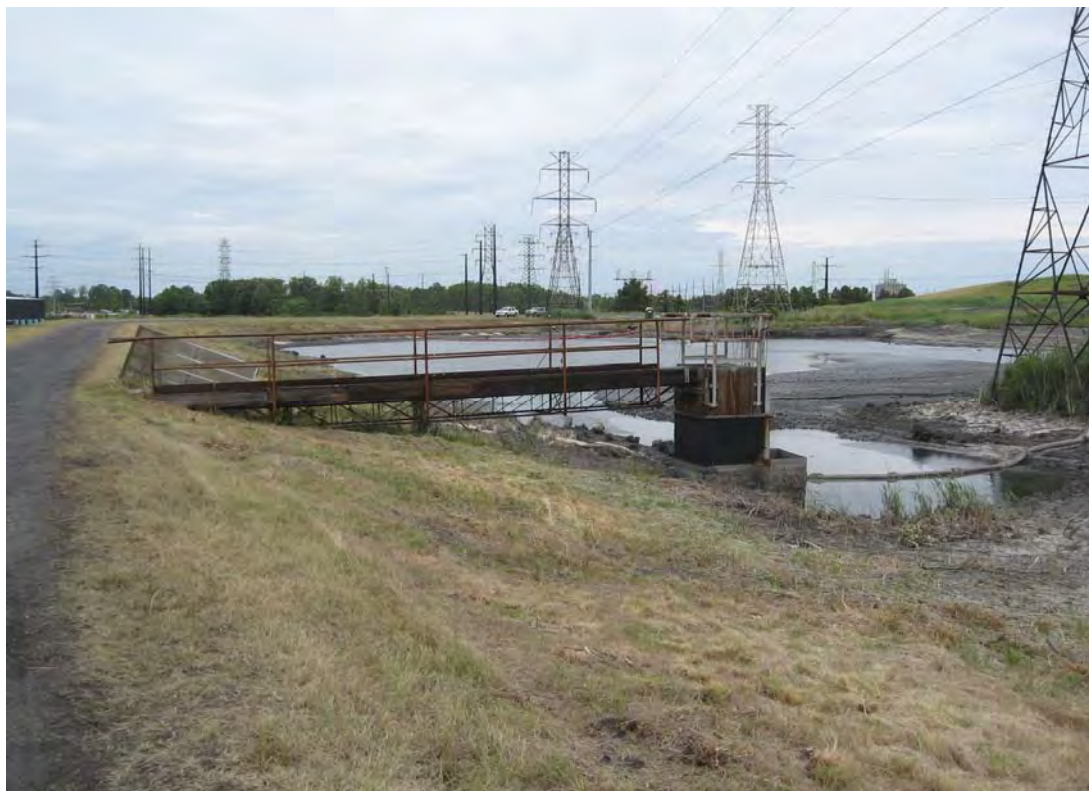
Photo Number:  
10

- The outlet structure appeared to be in good condition, discharge from the structure could not be observed because the pipe ends below the water surface in the Deep Creek.

Description:  
Inboard slope of  
southern  
embankment  
and outlet  
structure

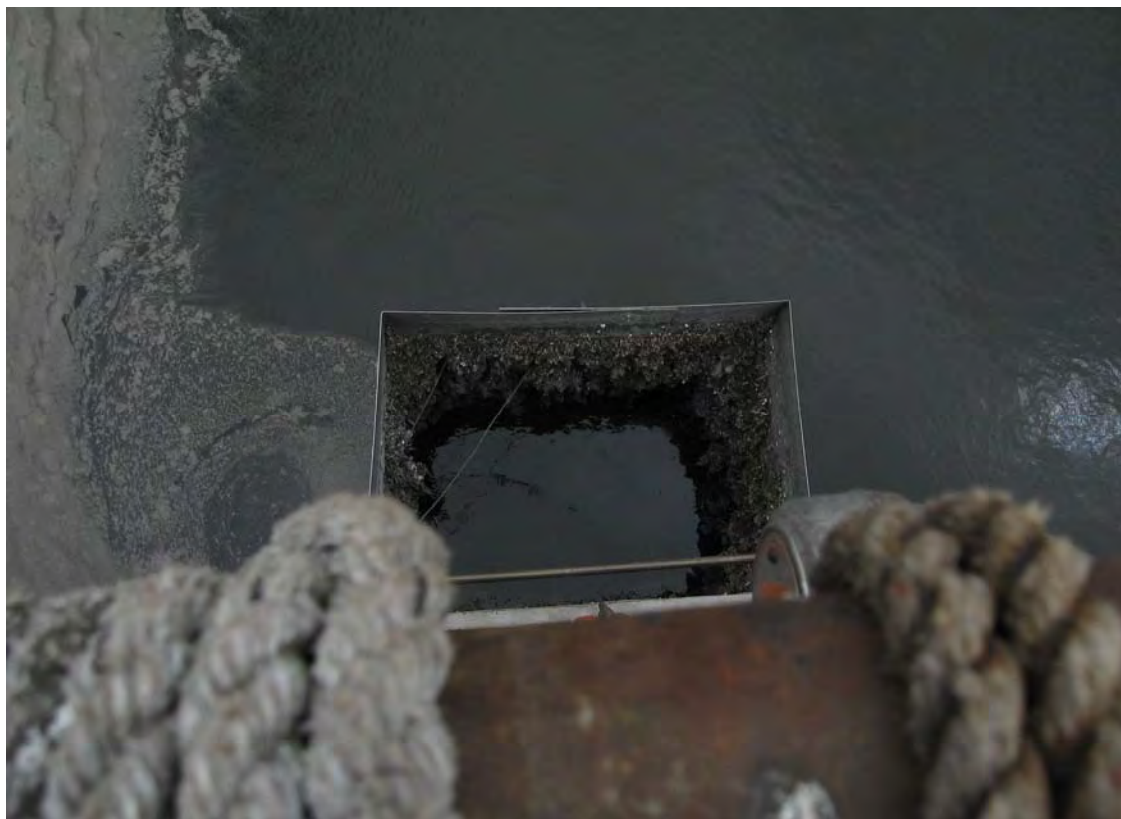
Photo Number:  
11

Description:  
Debris baffle for  
outlet structure

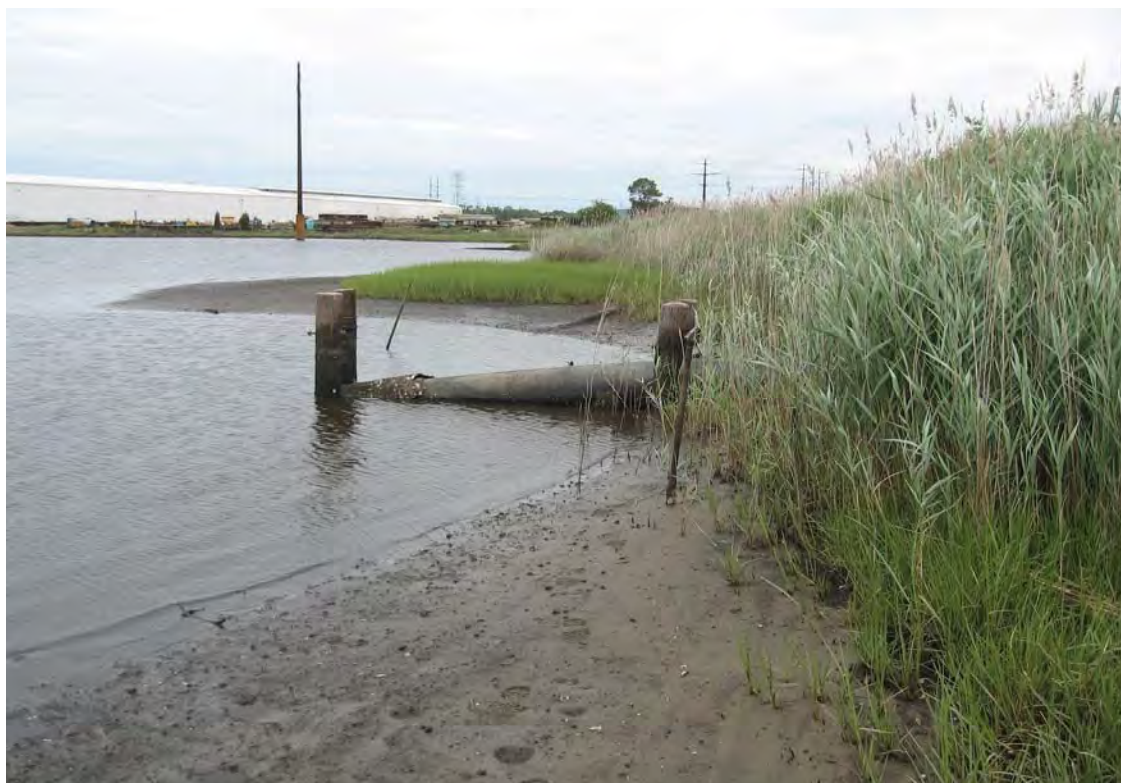
Photo Number:  
12

Description:  
Discharge end  
of 20-inch HDPE  
outlet pipe  
through  
southern  
embankment  
into Deep Creek

Note  
submerged  
downstream  
end of pipe

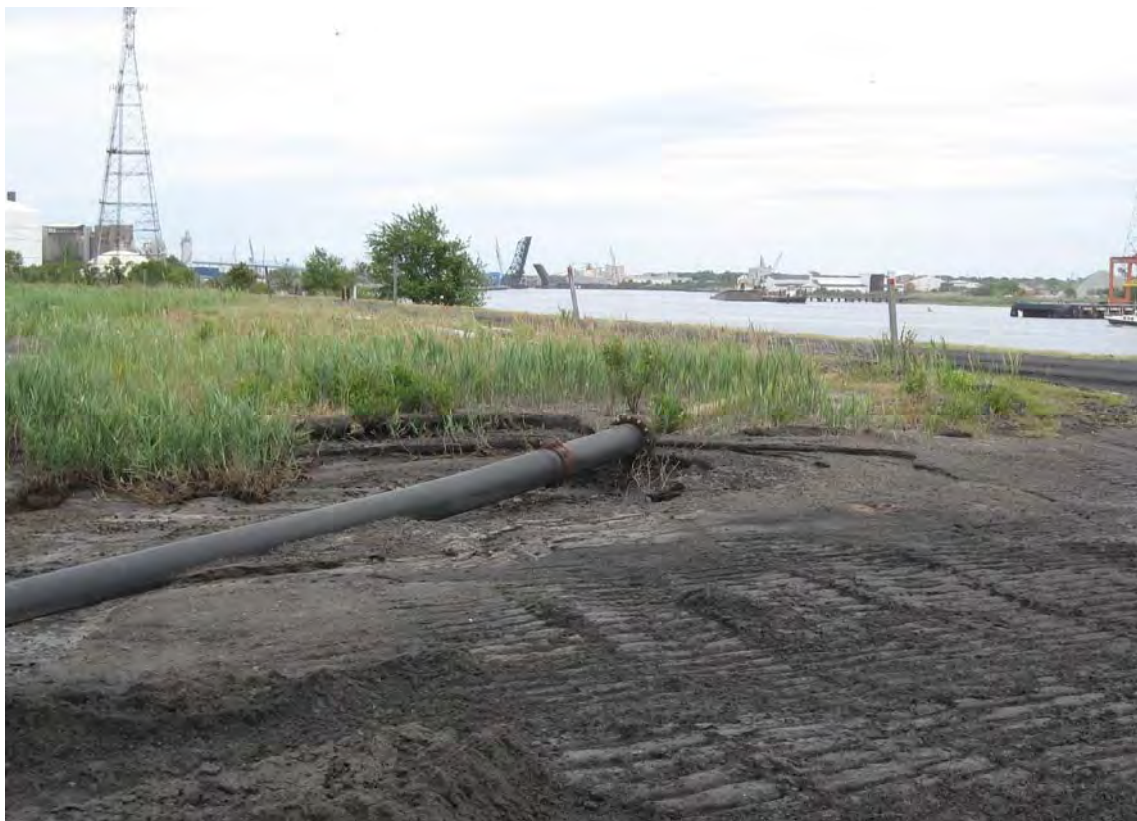
Photo Number:  
13

Description:  
Influent pipe

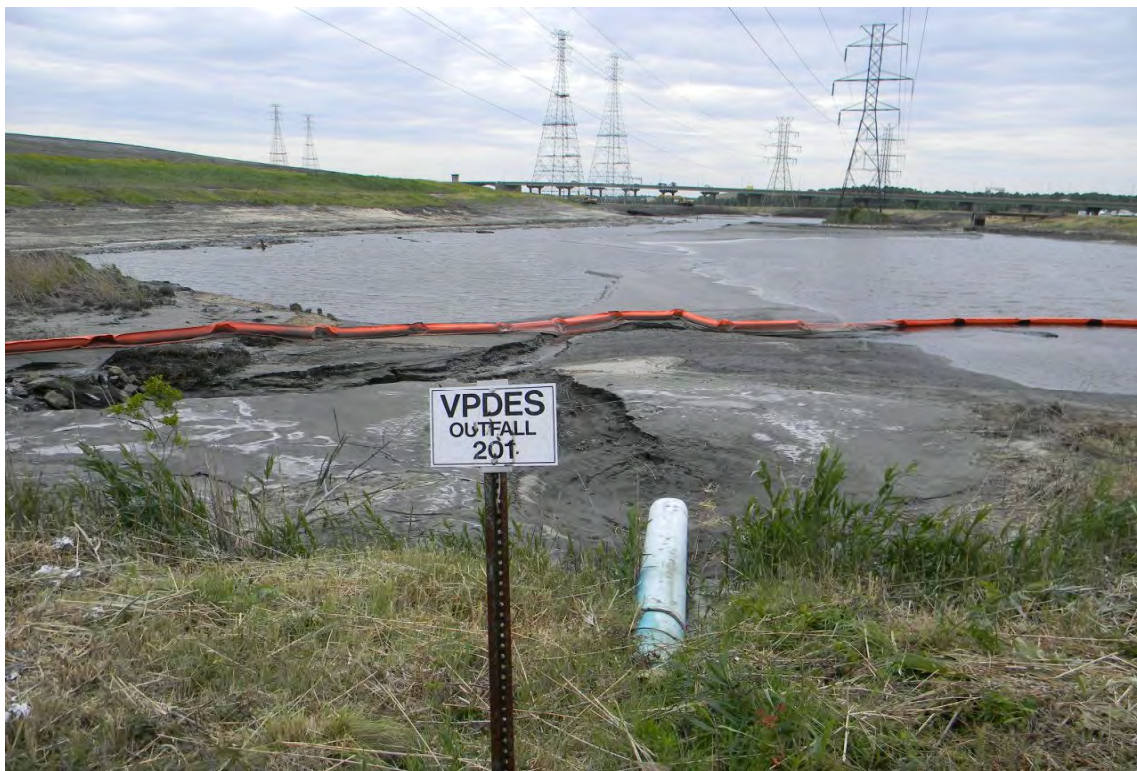
Photo Number:  
14

Description:  
Interior of  
Bottom Ash and  
Sedimentation  
Pond. Photo  
taken from  
western  
embankment

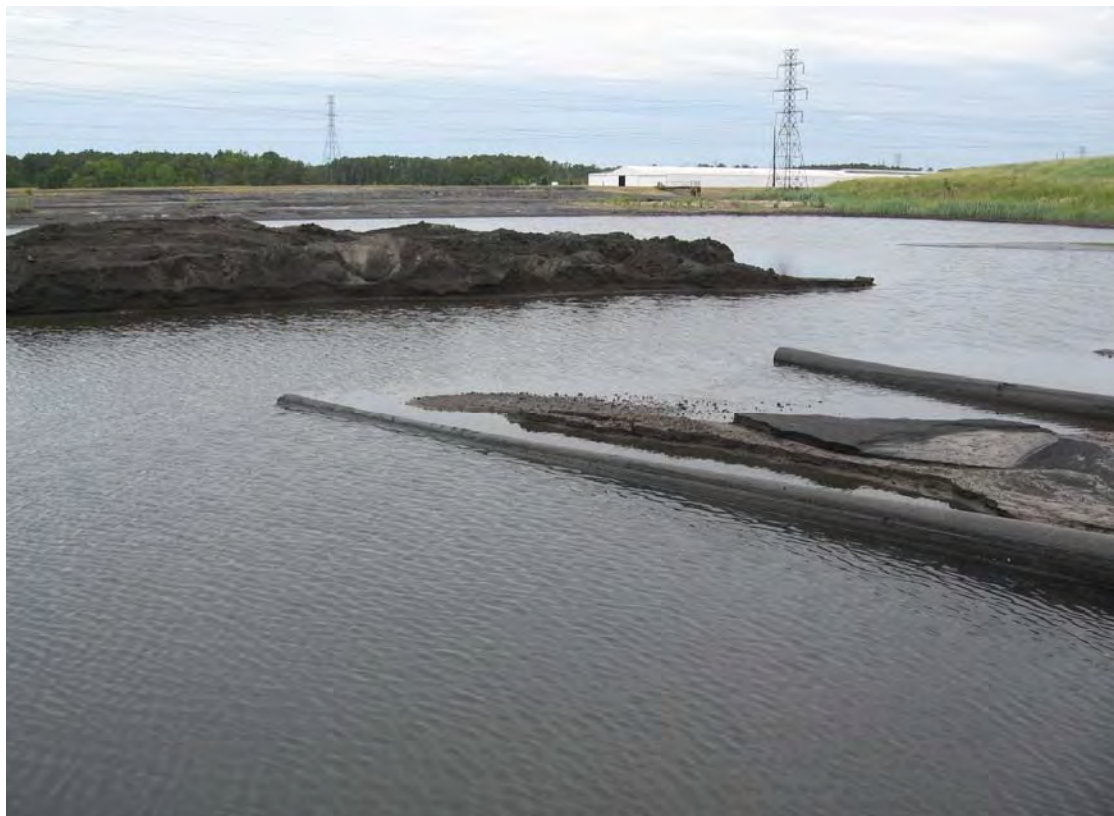
Photo Number:  
15

Description:  
Interior of  
Bottom Ash and  
Sedimentation  
Pond. Photo  
depicts CCW  
dividing dike  
that has been  
breached for  
reconstruction

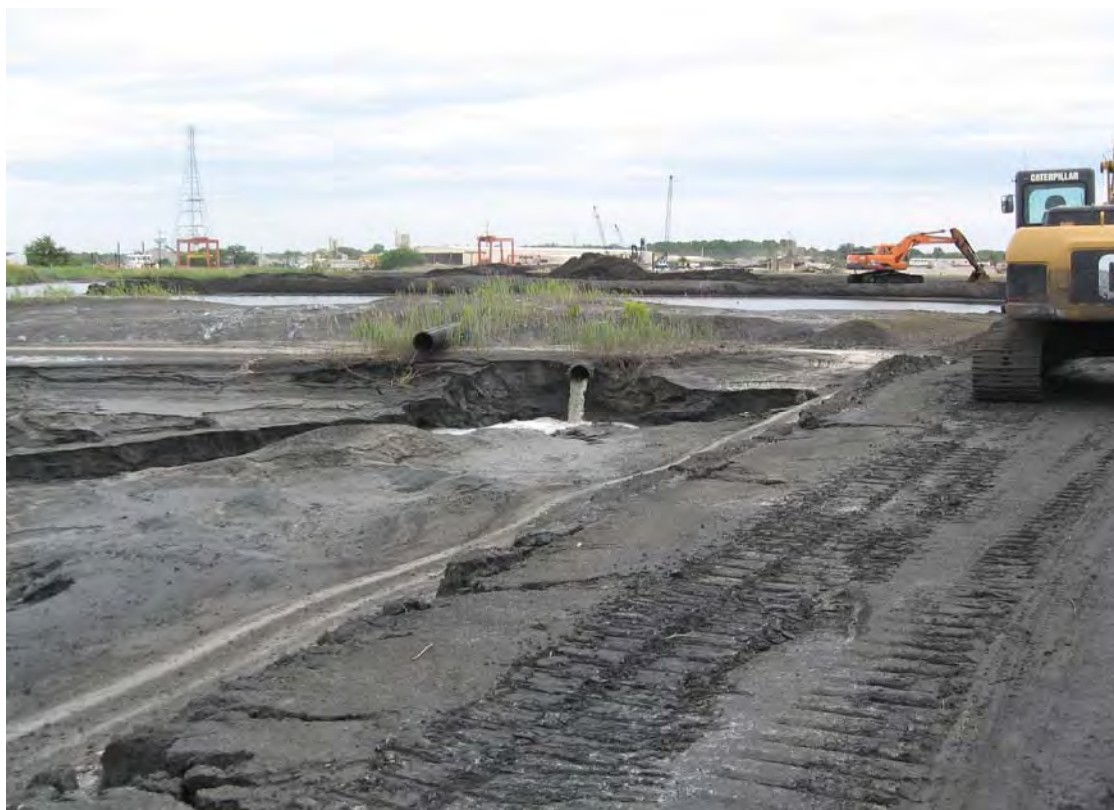
Photo Number:  
16

Description:  
Decant pipe  
from  
easternmost  
portion of the  
impoundment  
into western  
portion

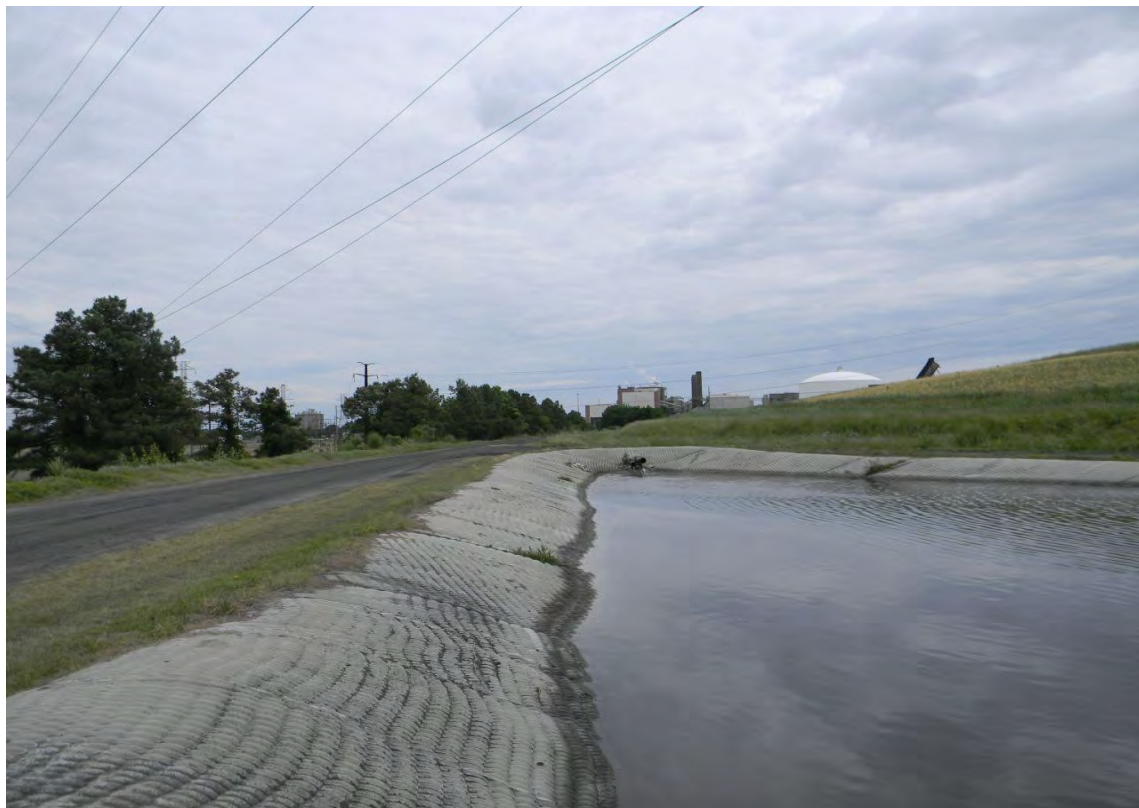
Interior of Oily  
Waste Pond
